Milestone Inspection – Phase 1

Gulf Front Lagoon

502 S. Florida Ave. Tarpon Springs, FL 34689

February 5, 2024

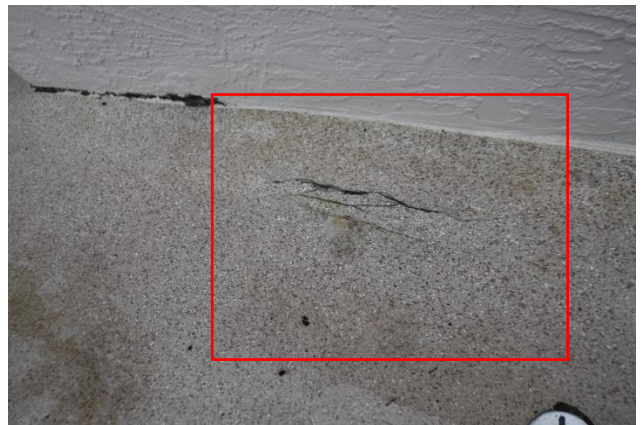
- Building #502, Level 1 near unit #115
 - Walkway coating shows signs of damage around walkway drain.
- Building #502, Ground Level Balcony of unit #115
 - Moisture intrusion at Balcony Railing causing cracks in the stucco cladding.
- Building #502, Level 2
 - No concerns of note
- Building #502, Level 3
 - No concerns of note
- Building #502, Level 4
 - No concerns of note

6 Building #502 Damaged Walkway Coating near unit #115

For the Exterior Walls/Breezeways, we do not recommend that the walkways have a Phase 2 destructive testing performed. We recommend that repairs to the debonded walkway coating is repaired and that the painting/waterproofing schedule is strictly adhered to. As part of a yearly inspection, we recommend that any surficial cracks developing are sealed with elastomeric sealer between formal painting cycles. In addition, the balcony railing at unit #115 should be removed and replaced along with repairs to the moisture damaged stucco cladding.

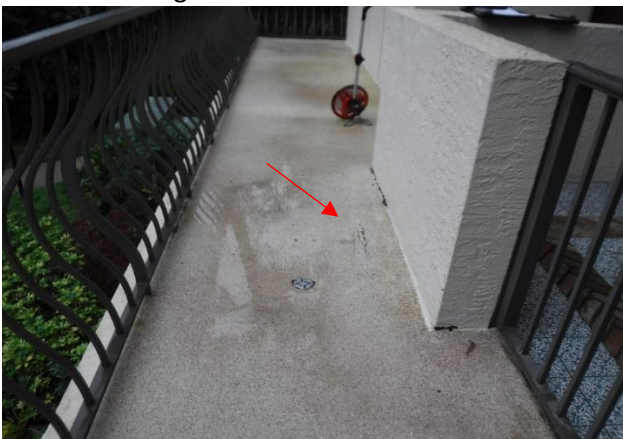
7 Building #502 Damaged Walkway Coating near unit #115

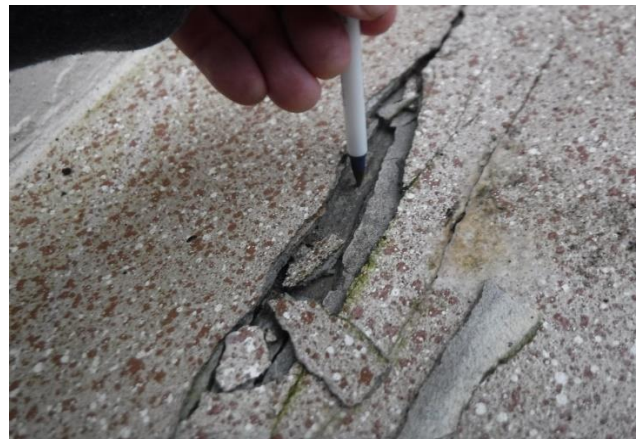
8 Building #502 Damaged Walkway Coating near unit #115

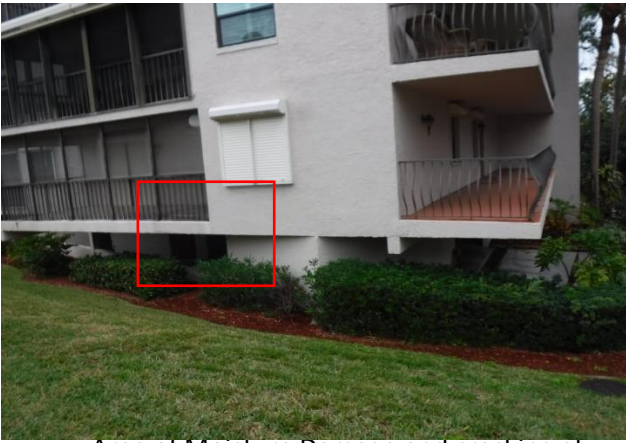
9 Area of Moisture Damage and cracking at Railing on the Balcony of unit # 115

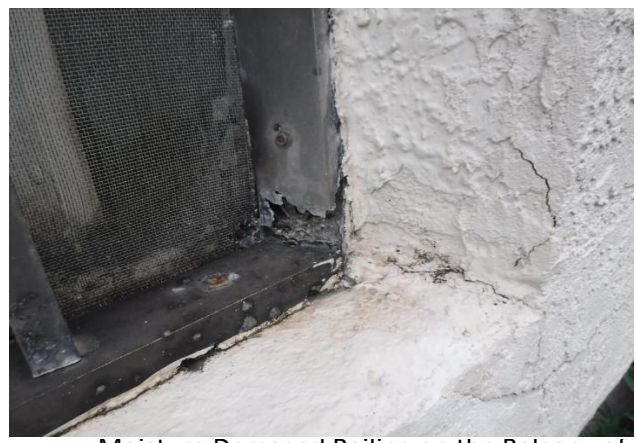
10 Moisture Damaged Railing on the Balcony of unit # 115

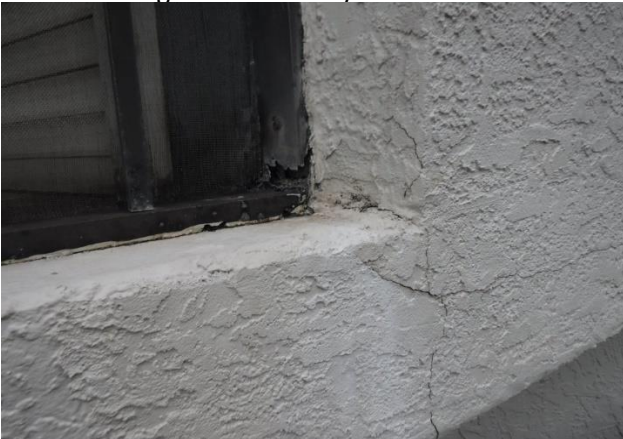
11 Area of Moisture Damage and cracking at Railing on the Balcony of unit # 115

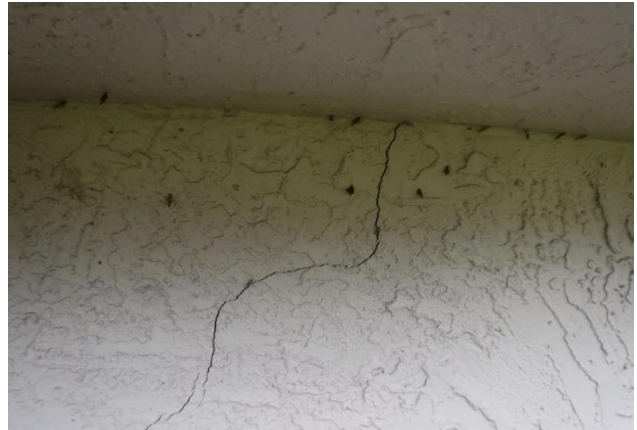
12 Area of step cracking at CMU's rear side of unit # 115

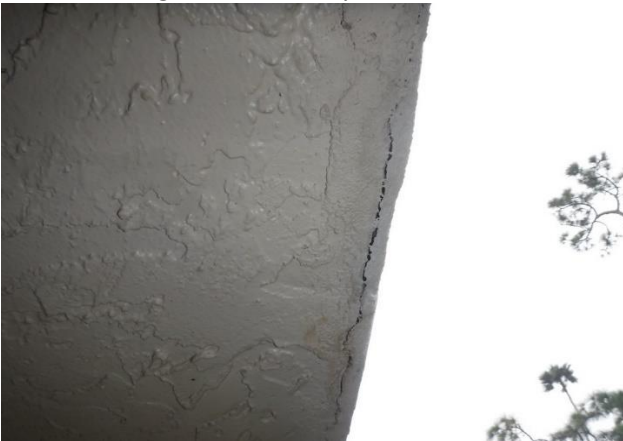
13 Area of Moisture Damage and cracking at Railing on the Balcony of unit # 115

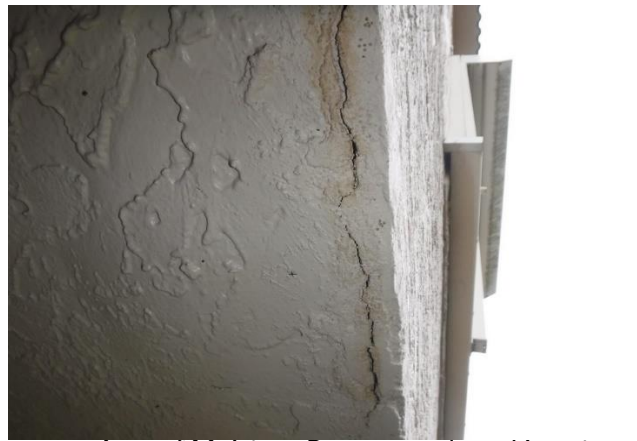
14 Area of Moisture Damage and cracking at Railing on the Balcony of unit # 115

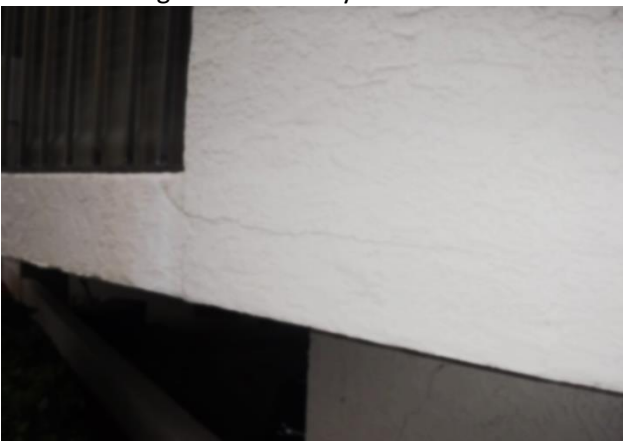
15 Area of Moisture Damage and cracking at Framed, Stucco wall of unit # 115

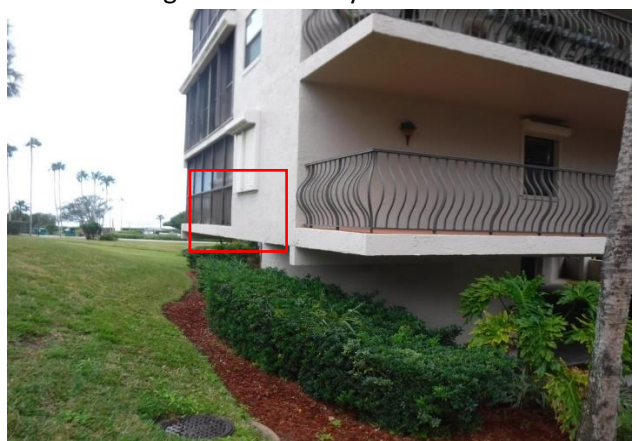
16 Area of Moisture Damage and cracking at Railing on the Balcony of unit # 115
