Contract # 44171

Milestone Inspection – Phase 1

Gulf Front Lagoon

504 S. Florida Ave. Tarpon Springs, FL 34689

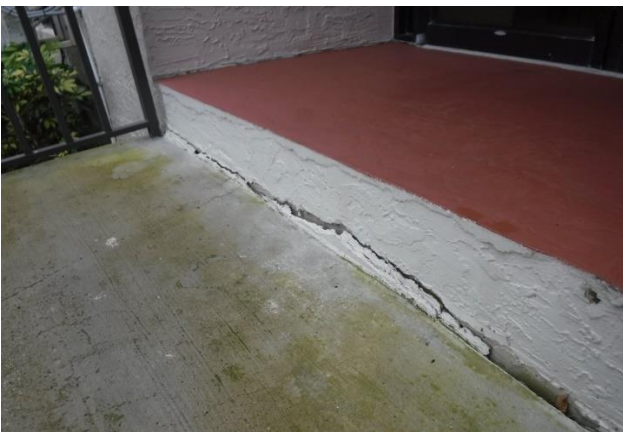
- Stairs at the East side of Building #504
 - No concerns of note
- Stairs at the Center side of Building #504
 - No concerns of note
- Stairs at the East side of Building #504
 - No concerns of note
- Exterior Stairs and Stoop at the Front Entry
 - The front entrance stoop was observed to be pulling away from the building.

5 Separation at the front Stoop

For the exterior stairs, we do not recommend that the front stairs and stoop have a Phase 2 destructive testing performed as there was no concern with structural compromising at the time of inspection. However, due to the settlement the front entrance stoop has pulled away from the building. The condition has created a potential tripping hazard through uneven steps and a sloped landing. We recommend a licensed contractor evaluate the front stoop and stairs and advise on repairs. Repairs to the sloping steps and stoop along with improved drainage should be addressed to remediate the issue.

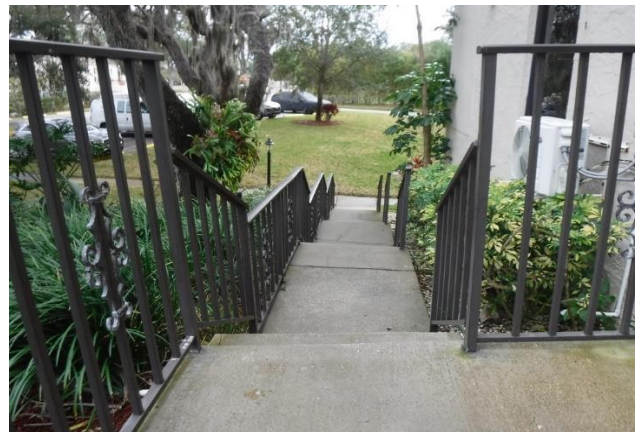
6 Uneven Stairs due to settlement

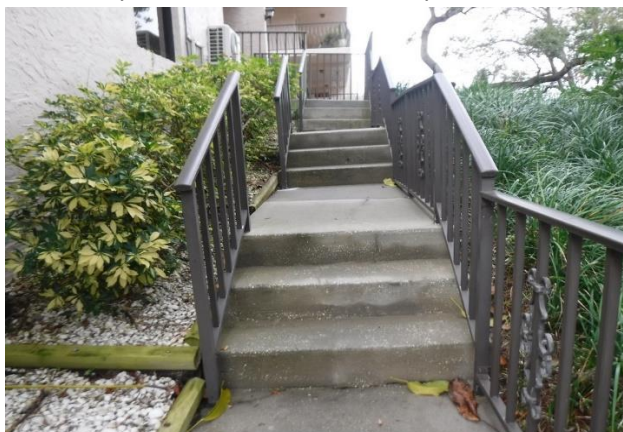
7 Uneven Stairs due to settlement

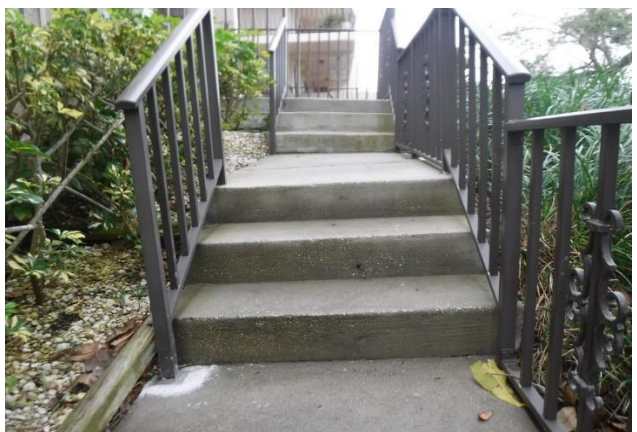
8 Uneven Stairs due to settlement

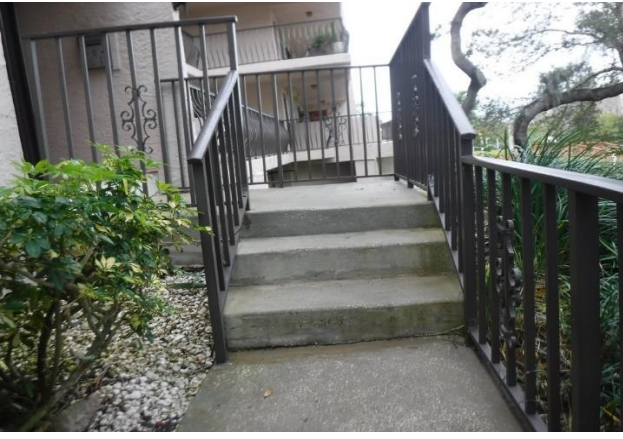
9 Uneven Stairs due to settlement

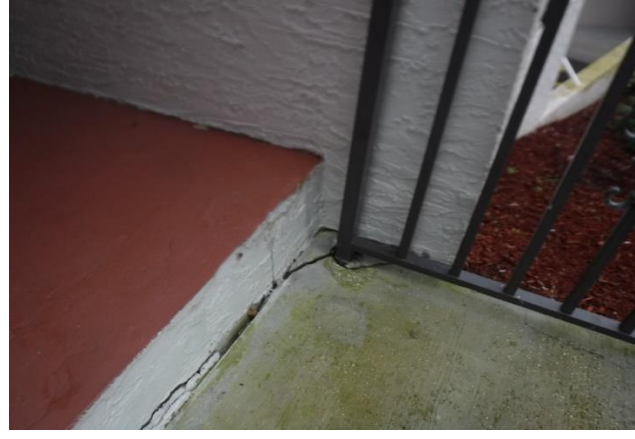
10 Separation at the front Stoop
